GROUP BODY	MODEL 2016MY Sorento (UMa)
	NUMBER 125	DATE August 2016
TECHNICAL SERVICE BULLETIN		
SUBJECT:	PANORAMIC SUNROOF SLOW TO CLOSE AND/OR ABNORMAL NOISE WHEN CLOSING

This bulletin provides the procedure to repair a panoramic sunroof that exhibits a slow to close condition and/or abnormal noise when closing, on some 2016MY Sorento (UMa) vehicles produced from October 27, 2014 through January 23, 2016. Follow the procedure in this bulletin to clean, lubricate, and replace the rear tilt levers to correct the concern. Do NOT replace the sunroof assembly for this concern.

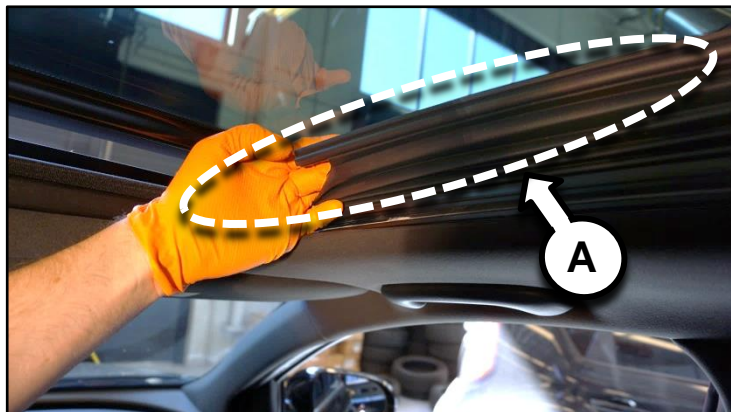
2. With the panoramic sunroof roller blind retracted, carefully remove the accordion covers (A) on the right and left side.

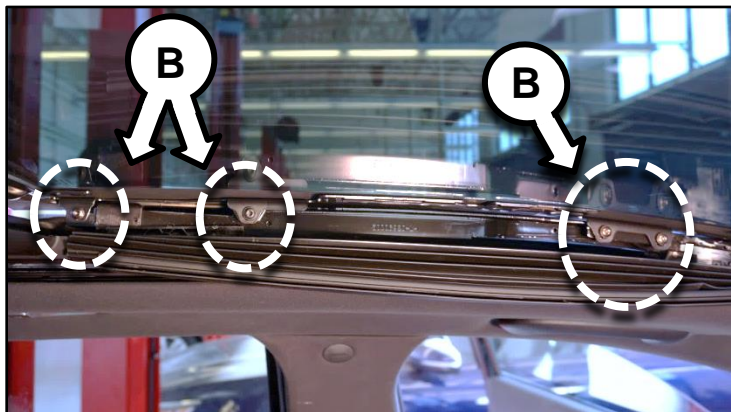
3. Using a T20 Torx® socket, remove the 4 screws (B) on the right and left side.

Use caution not to scratch or damage the glass during removal of the screws.

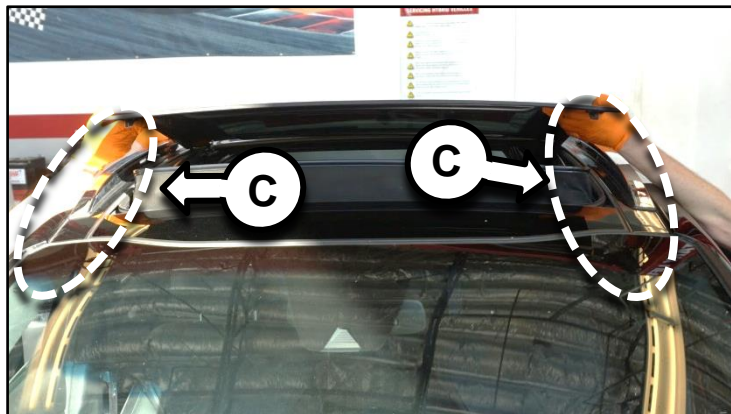
4. With the assistance of another person, remove the panoramic sunroof glass by sliding the glass towards the front of the vehicle until the sliders are out of the tracks (C).

Use caution not to scratch, damage, or break the glass during removal.

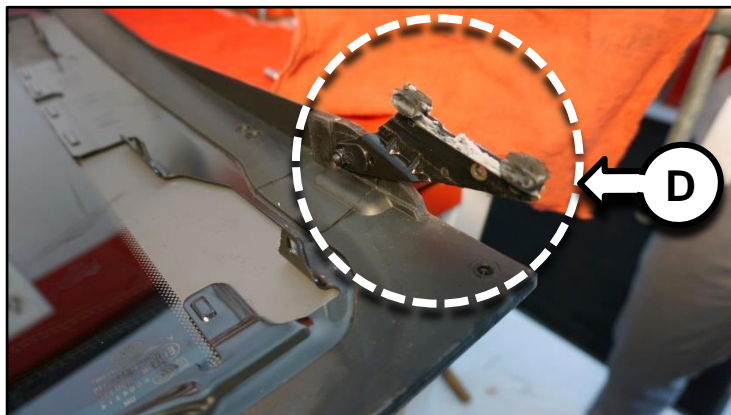
5. Lay the glass on a soft, flat, protected surface with the tilt levers (D) facing up.

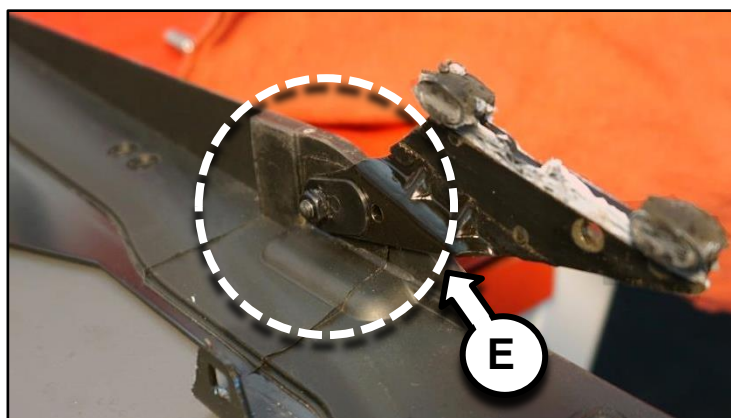
6. Using an 8mm socket, remove the nuts securing the tilt levers on both sides (E). Replace the tilt levers with new parts and tighten the nuts to the specified torque.

Tightening torque:
72 ~ 96 in·ft (8 ~ 11 N·m)

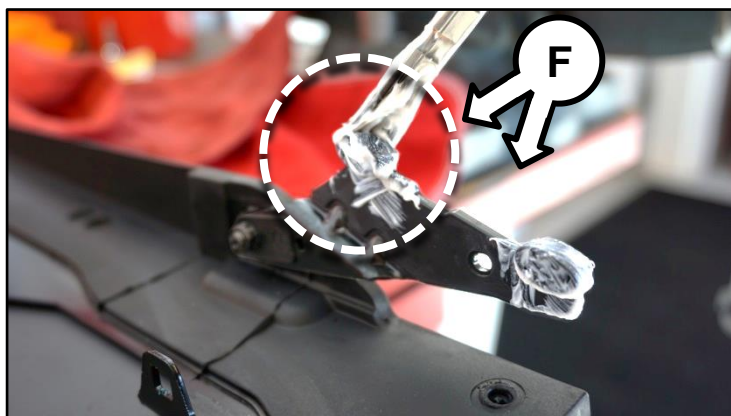
7. Lightly coat the tilt lever shoes (F) using the specified lubricant.

Failure to use the lubricant specified on page 7 of this bulletin may result in an ineffective or repeat repair.

Do not use Kia Dampening Grease (P/N UM011-CHA052), as it is not compatible with the grease used by the factory.

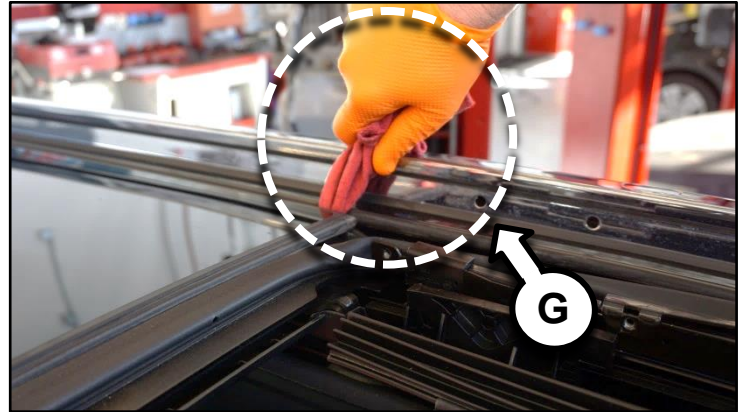
8. Using a non-marring trim panel tool and a clean shop towel (G), clean the rear guide rails on both sides until there are no foreign materials present on the rag.

Use a non-marring trim removal tool (Such as Snap-on® Part Number PBN5 or equivalent) to avoid damaging roof seals.

Failure to thoroughly remove any old grease or foreign material from the guides may result in an ineffective or repeat repair.

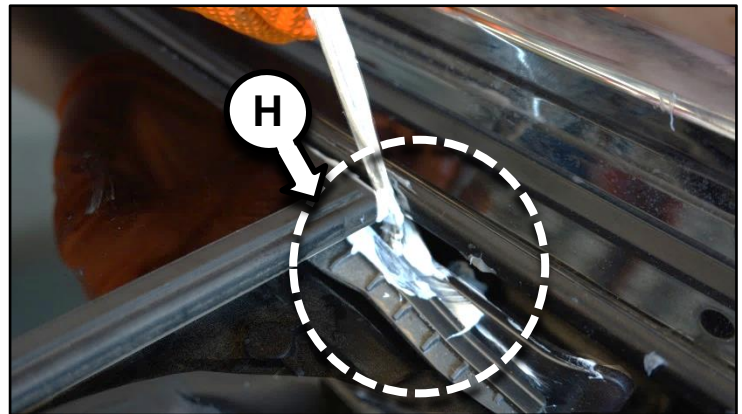
9. Using a clean brush, apply a sufficient amount of the specified lubricant to the entire length of both rear tracks (H).

(Approx. 15 grams of grease per track)

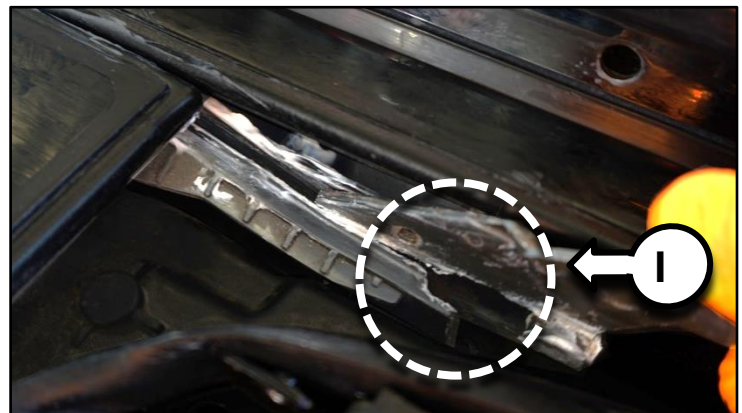
10. With the assistance of another person, carefully re-install the panoramic sunroof glass by inserting the tilt levers into the guide rail (I).

Ensure both tilt lever shoes are completely inserted or damage to the glass and/or sunroof assembly may result.

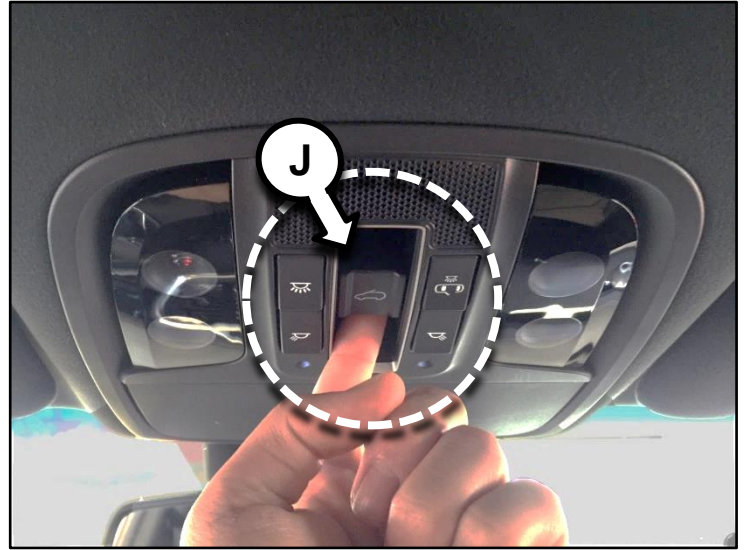
2. Press and hold the CLOSE button (J) for 10-15 seconds until the sunroof fully closes then retracts slightly. The sunroof operates as follows:

BLIND OPEN → GLASS TILT

Release the switch.

Perform step 3 within 5 seconds.
